Manhole Inspection Summary

Manhole # S71A1_006MH

Insp Date: **2/18/08 10:09 AM**

Location Address: **6700 Cameron Dr.**

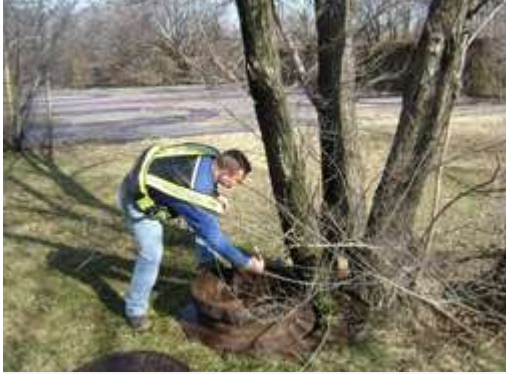
Location View

Comments **FRAME IS VERY OFFSET. THE MANHOLE IS RIGHT NEXT TO A LARGE TREE. NO ROOTS SHOWING IN BARREL, YET.**

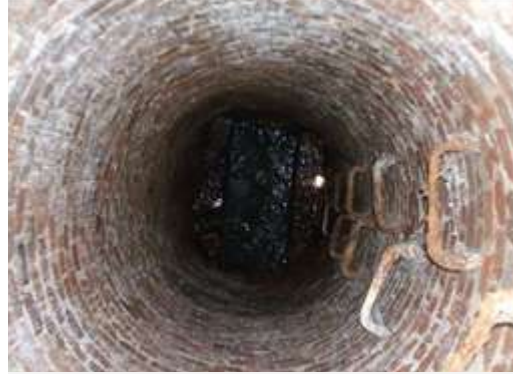
Top View

Frame loose and up against tree

infiltration in barrel above incoming 7 o'clock
